Manhole Inspection Summary

Manhole # S33O1_011MH

Insp Date: **2/4/08 8:45 AM**

Location Address: **717 Deaconhill Ct**

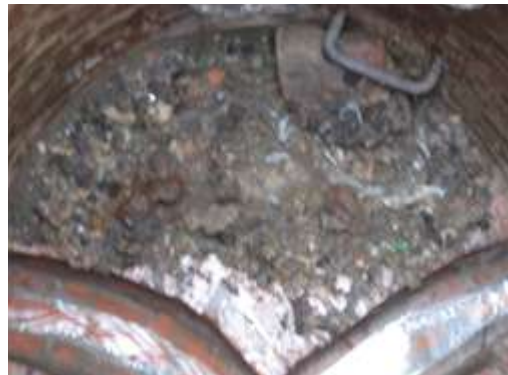
Defect 2

Condition: ☐ Sound ☐ Cracked ☐ Root Intrusion ☐ Deteriorated ☐ Leaks ☒ **Debris**

Debris

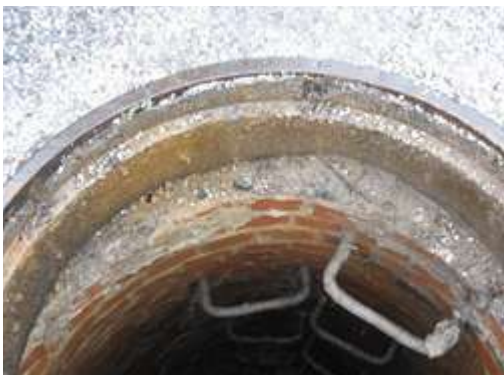
Defect 1

Offset: **2** (in.)

Frame offset

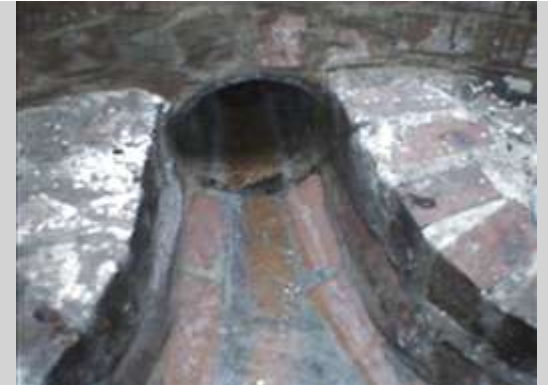
12 O'Clock Outflow

Pipe Height: **10.8** (in.) Rod and Bar (Angled)
Pipe Material: **Clay** ☐ Pipe Lined
Invert Depth: **11.15** (ft.) Flow Characteristics: **Fast**
Deposits: ☒ None ☐ Mud ☐ Sludge ☐ Debris ☐ Grease
Silt Depth: (in.) Deposits Extent:
Infiltration: **None** Pipe Seal Cond: **Sound**

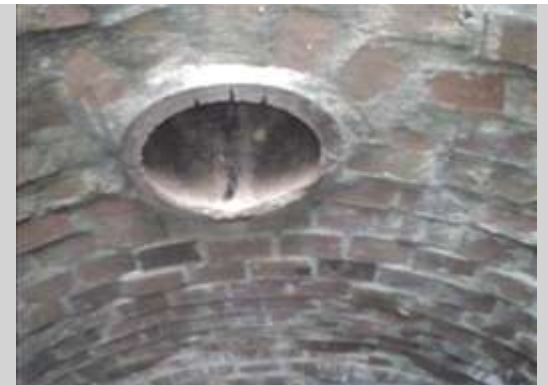
3 O'Clock Inflow

Pipe Height: **9.6** (in.) Rod and Bar (Angled)
Pipe Material: **Clay** ☐ Pipe Lined
Invert Depth: **7.57** (ft.) Flow Characteristics: **Fast**
Deposits: ☒ None ☐ Mud ☐ Sludge ☐ Debris ☐ Grease
Silt Depth: (in.) Deposits Extent:
Infiltration: **None** Pipe Seal Cond: **Sound**

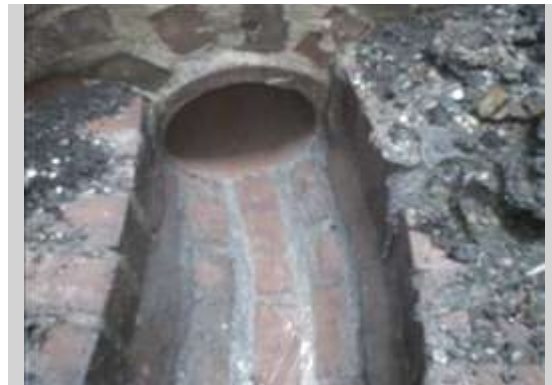
Drop: **Outside** Rod and Bar
Angled: **Yes** Reading: **10.06** (ft.)
Inv Depth: **11.06** (ft.)
Drop Condition: **Open**

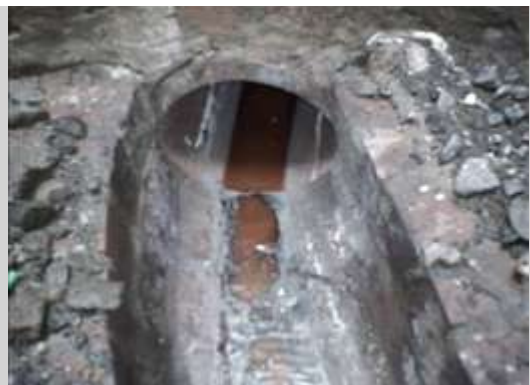
9 O'Clock Inflow

Pipe Height: **10.8** (in.) Rod and Bar (Angled)

Infiltration: **None** Pipe Seal Cond: **Sound**
